SR 3 MP 58.21 Unnamed Tributary to Hood Canal (991240): Preliminary Hydraulic Design Report

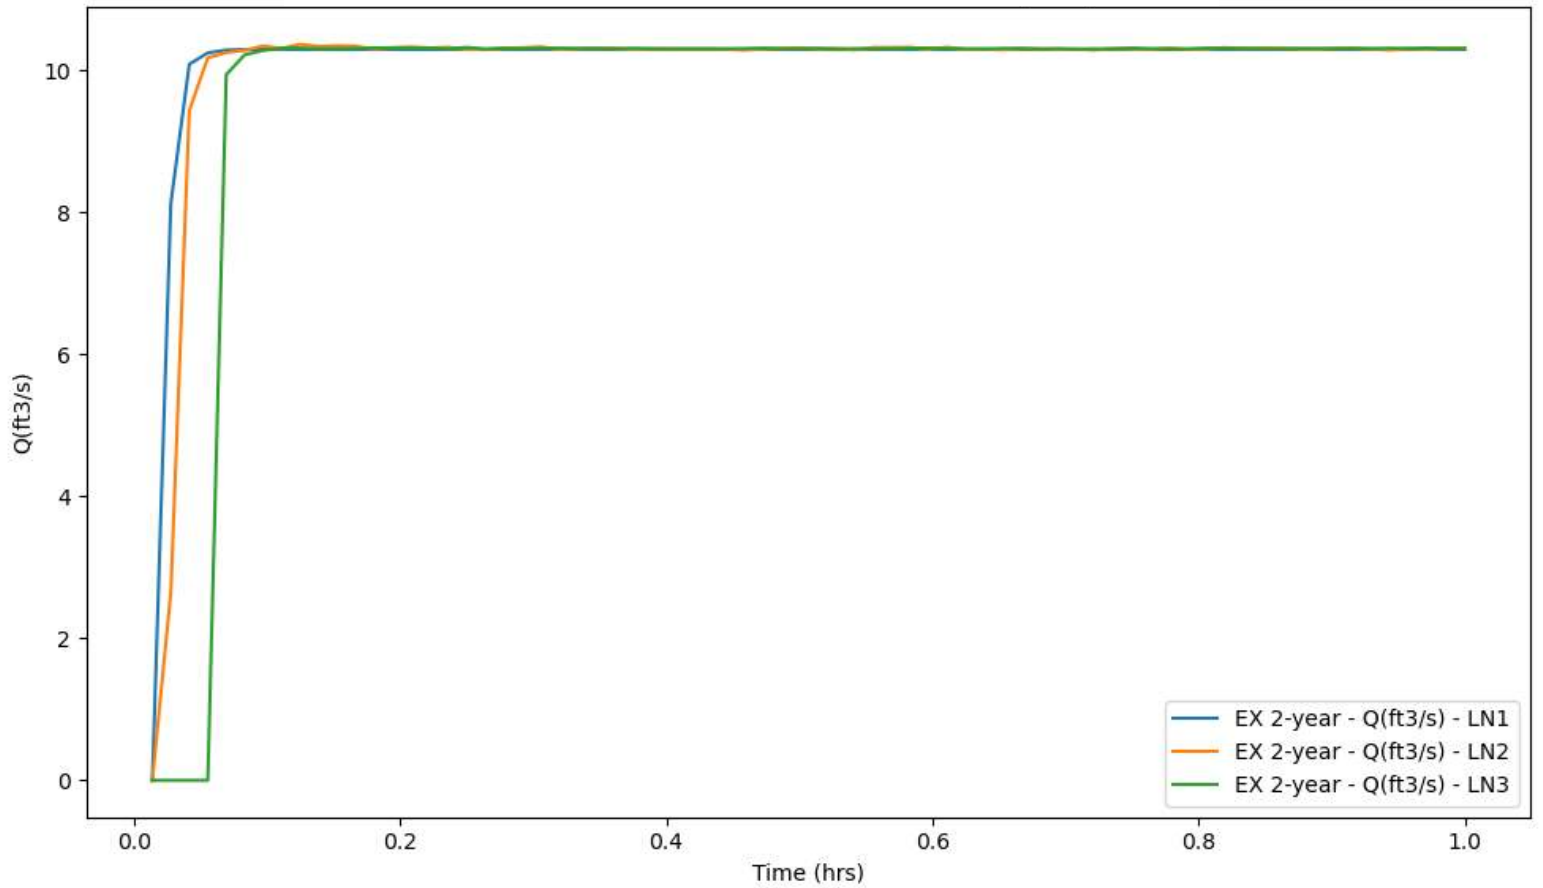
EXISTING 2-YEAR RESULTS

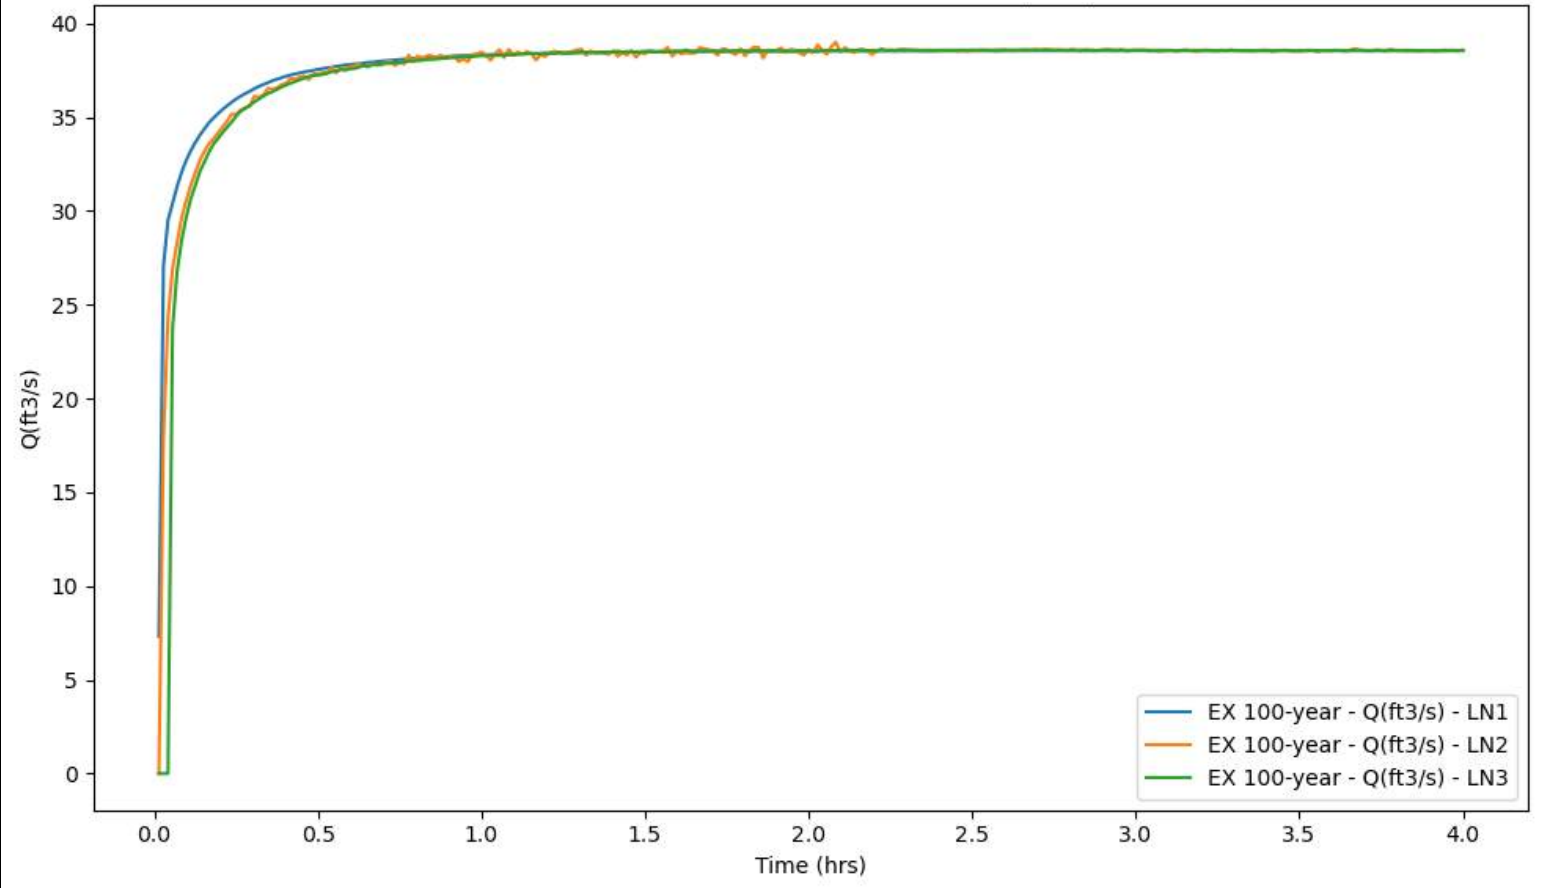
EXISTING 100-YEAR RESULTS

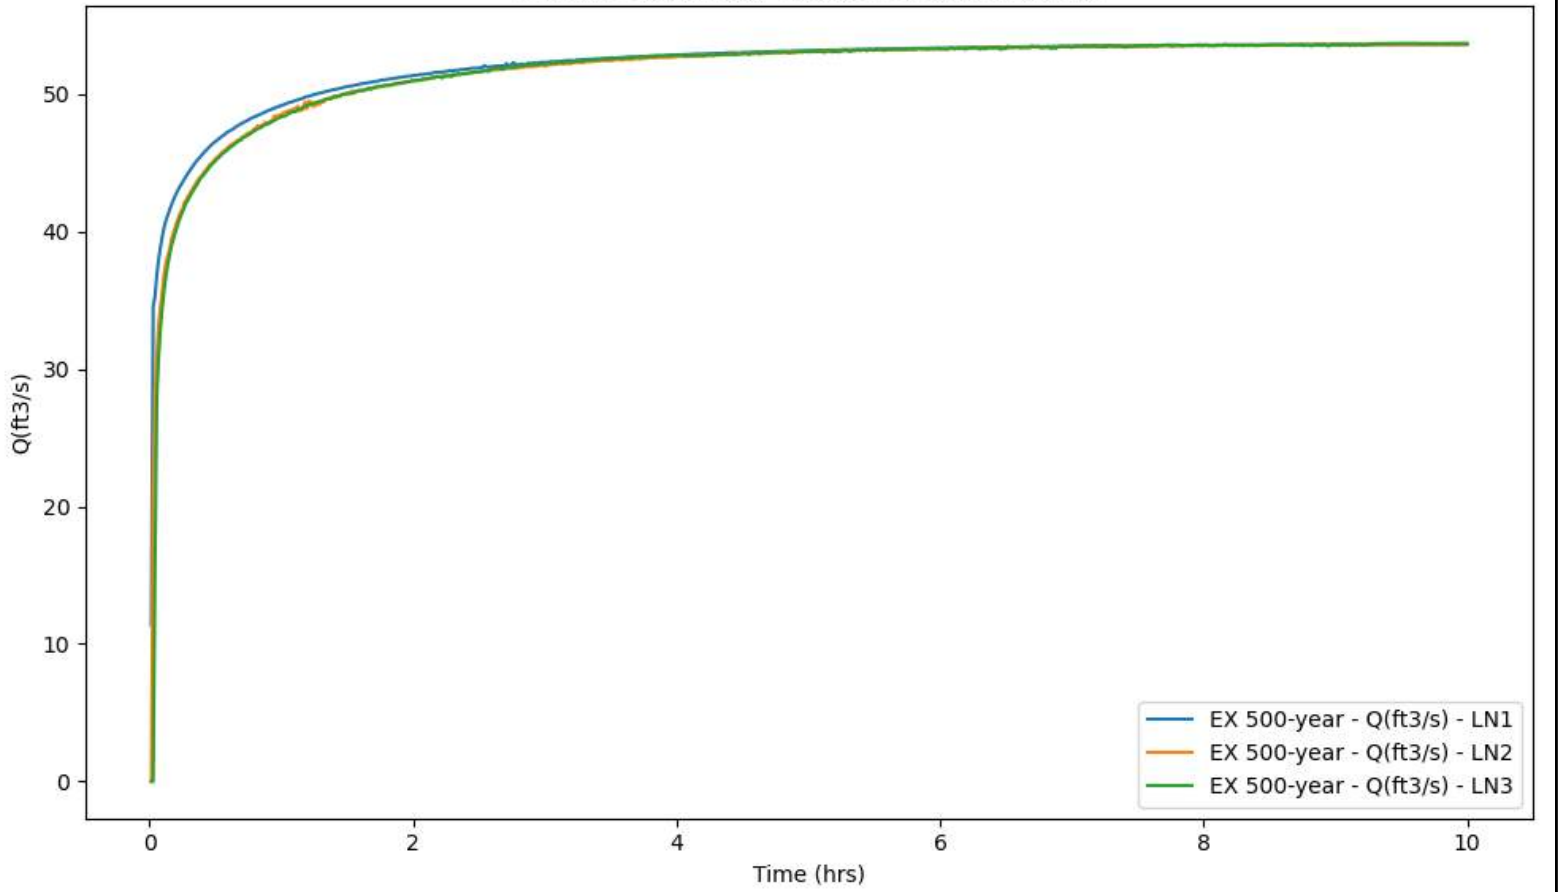
EXISTING 500-YEAR RESULTS

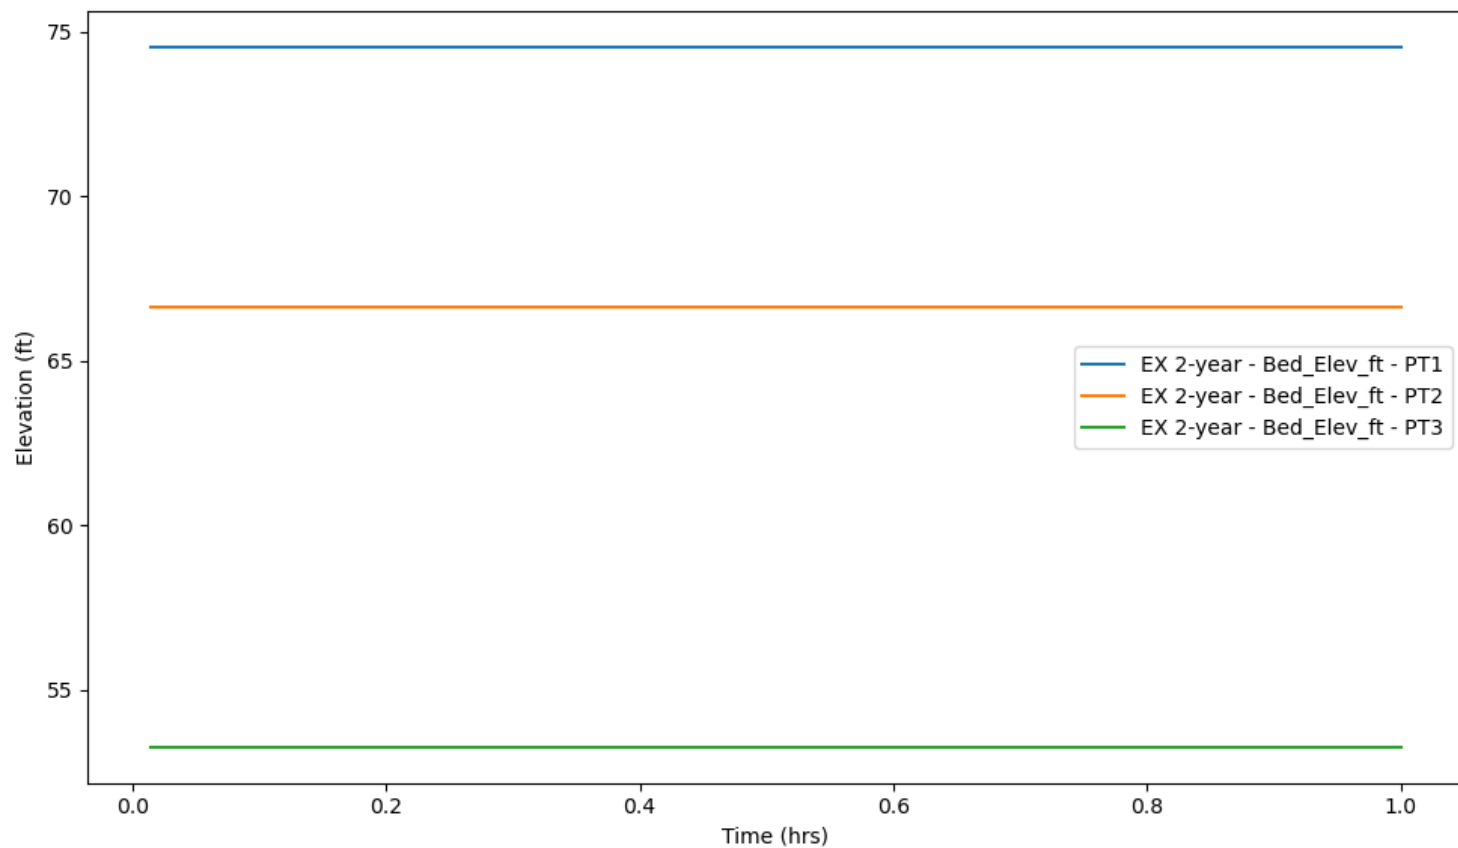
EXISTING 2-YEAR RESULTS

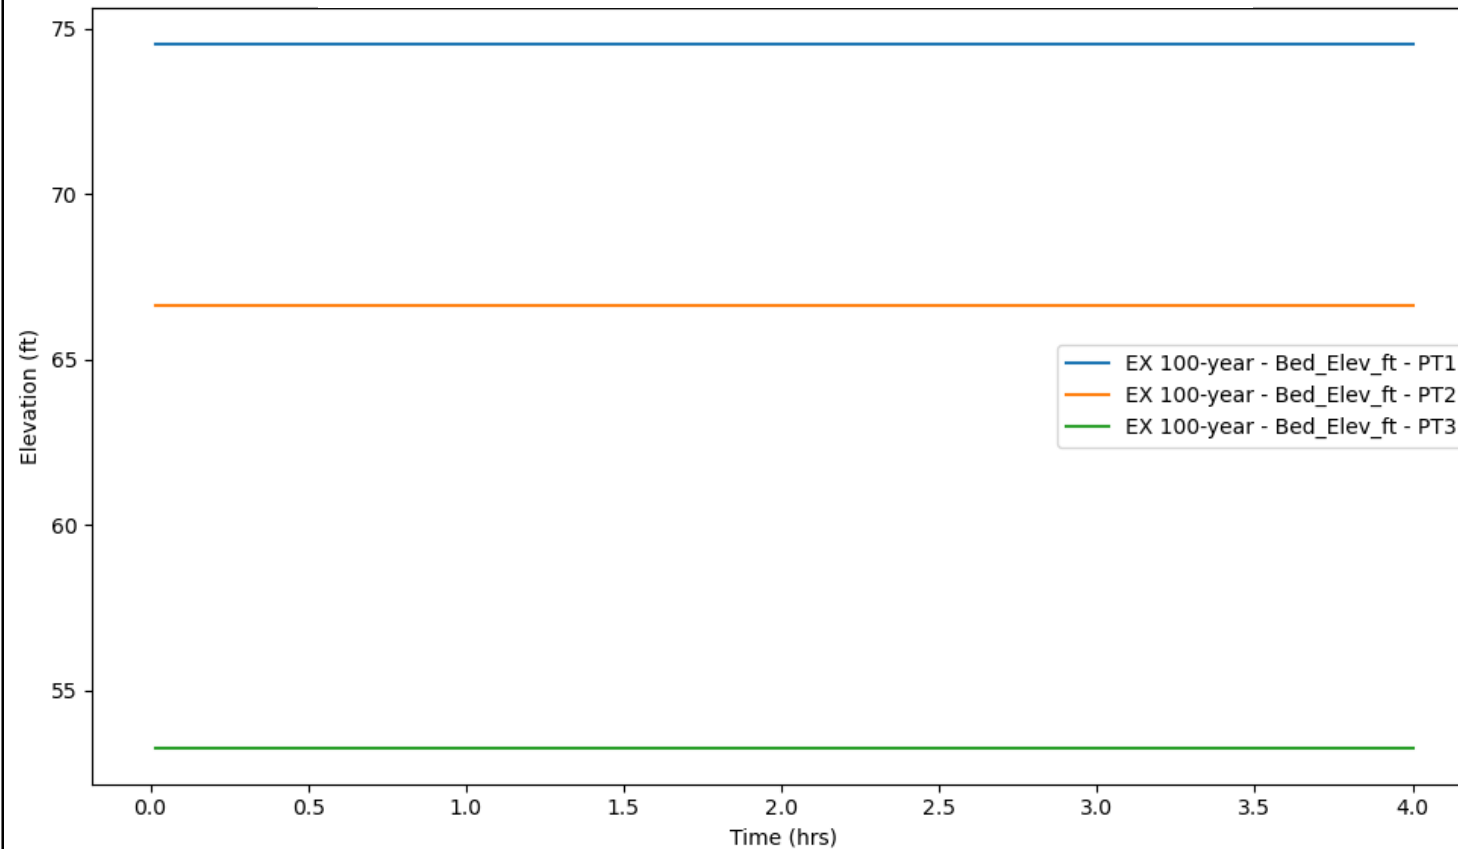
EXISTING 100-YEAR RESULTS

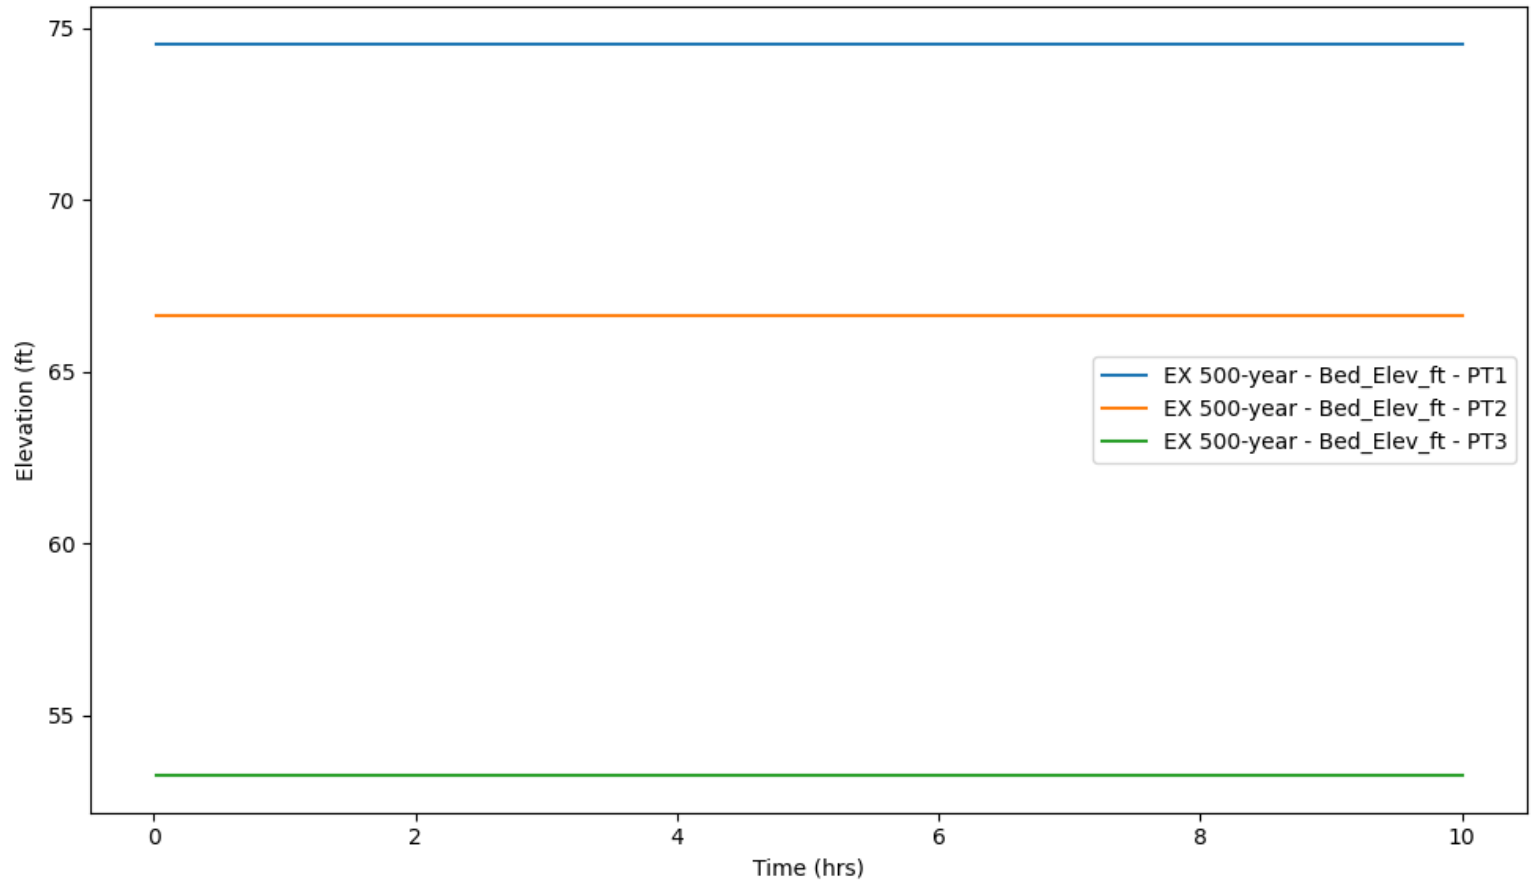
EXISTING 500-YEAR RESULTS

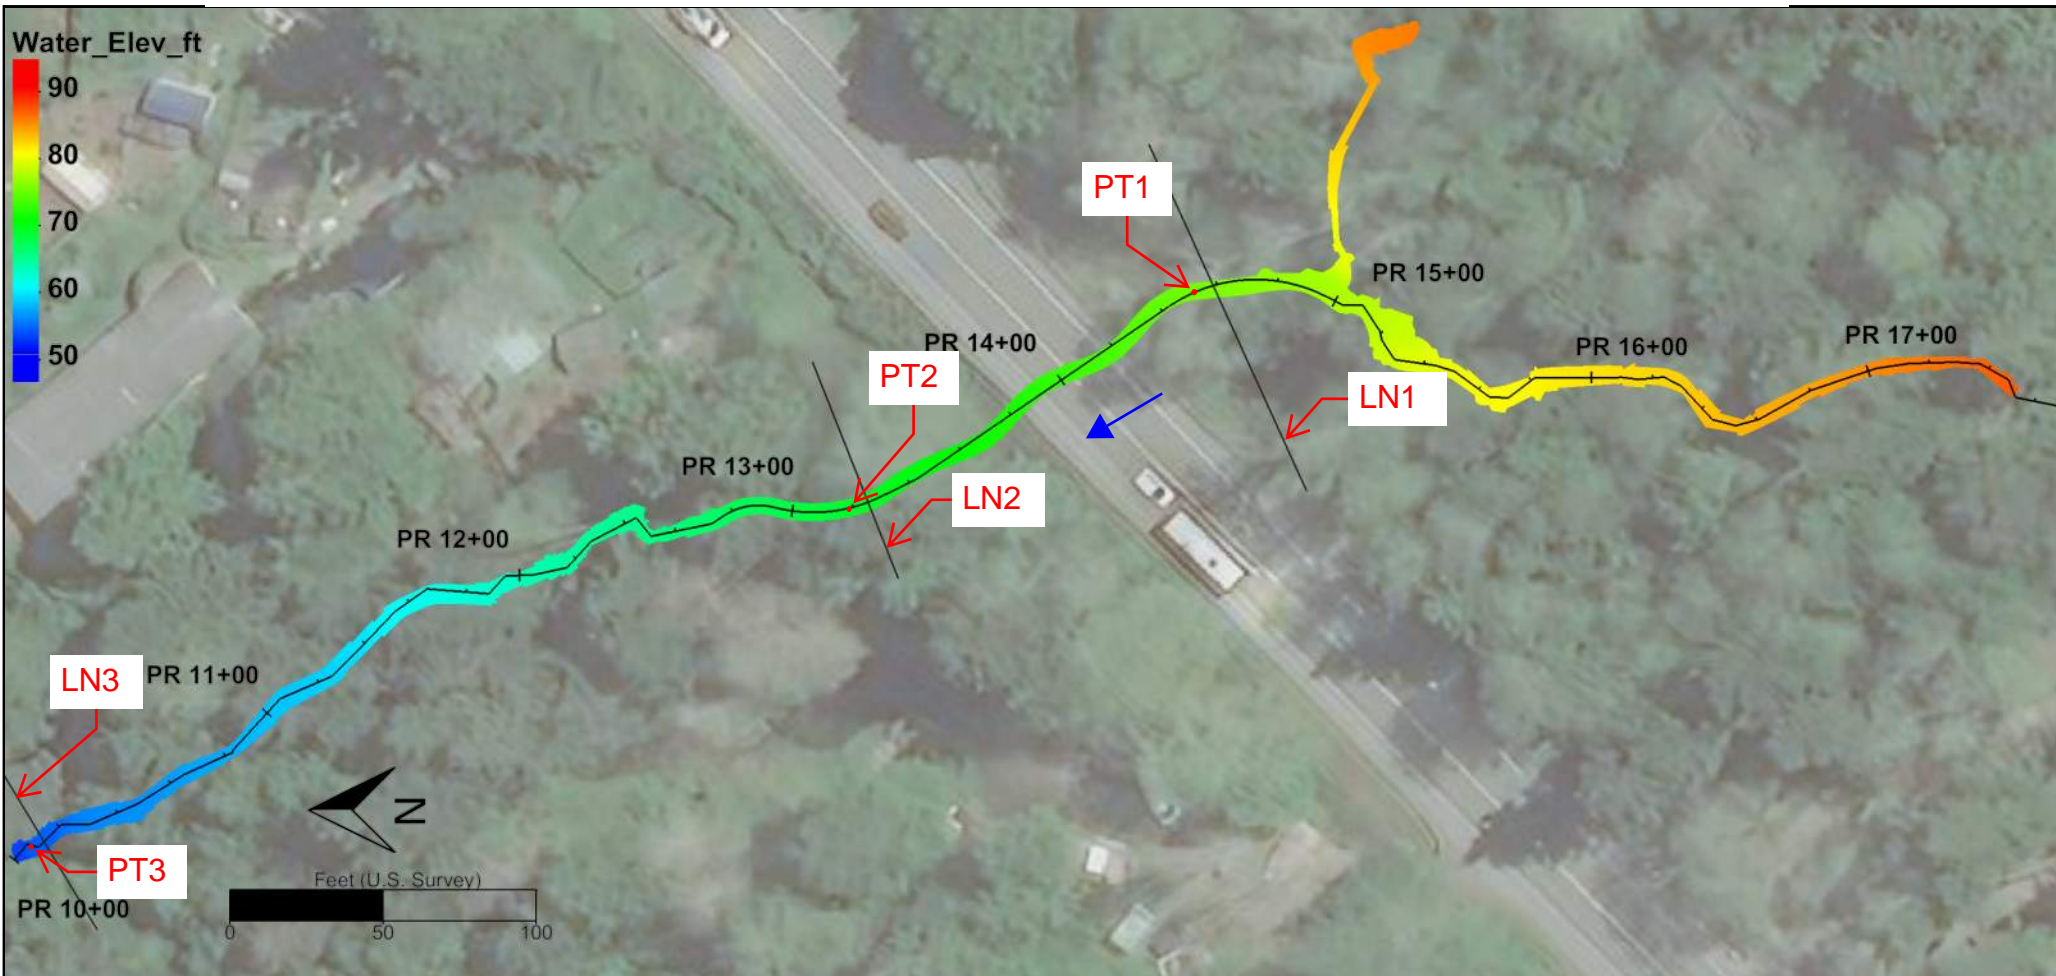
PROPOSED CONDITIONS MONITOR LINE AND POINT LOCATIONS

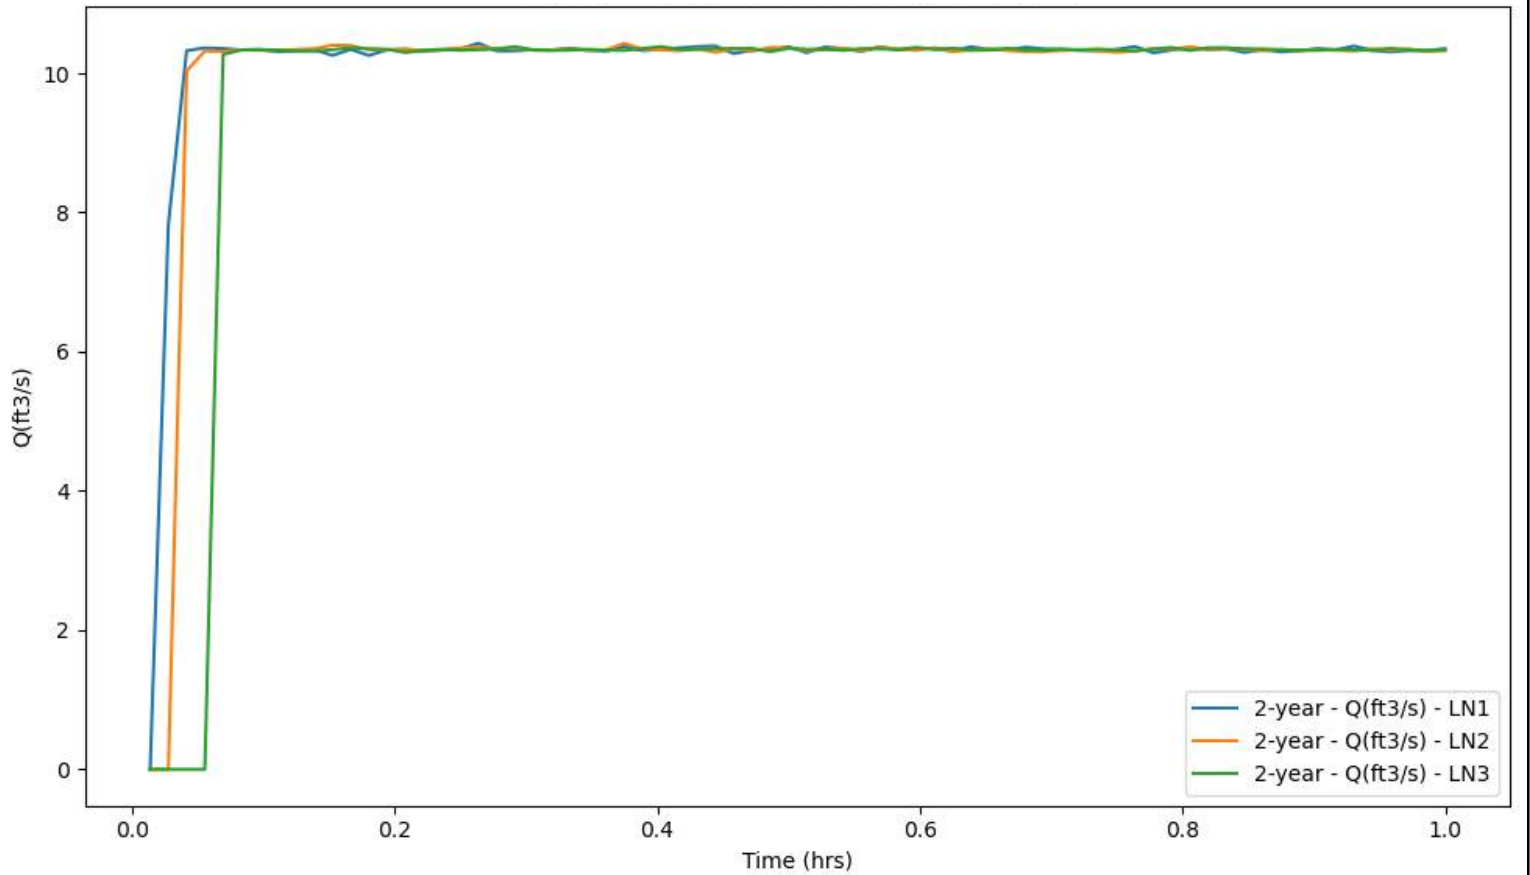
PROPOSED 2-YEAR RESULTS

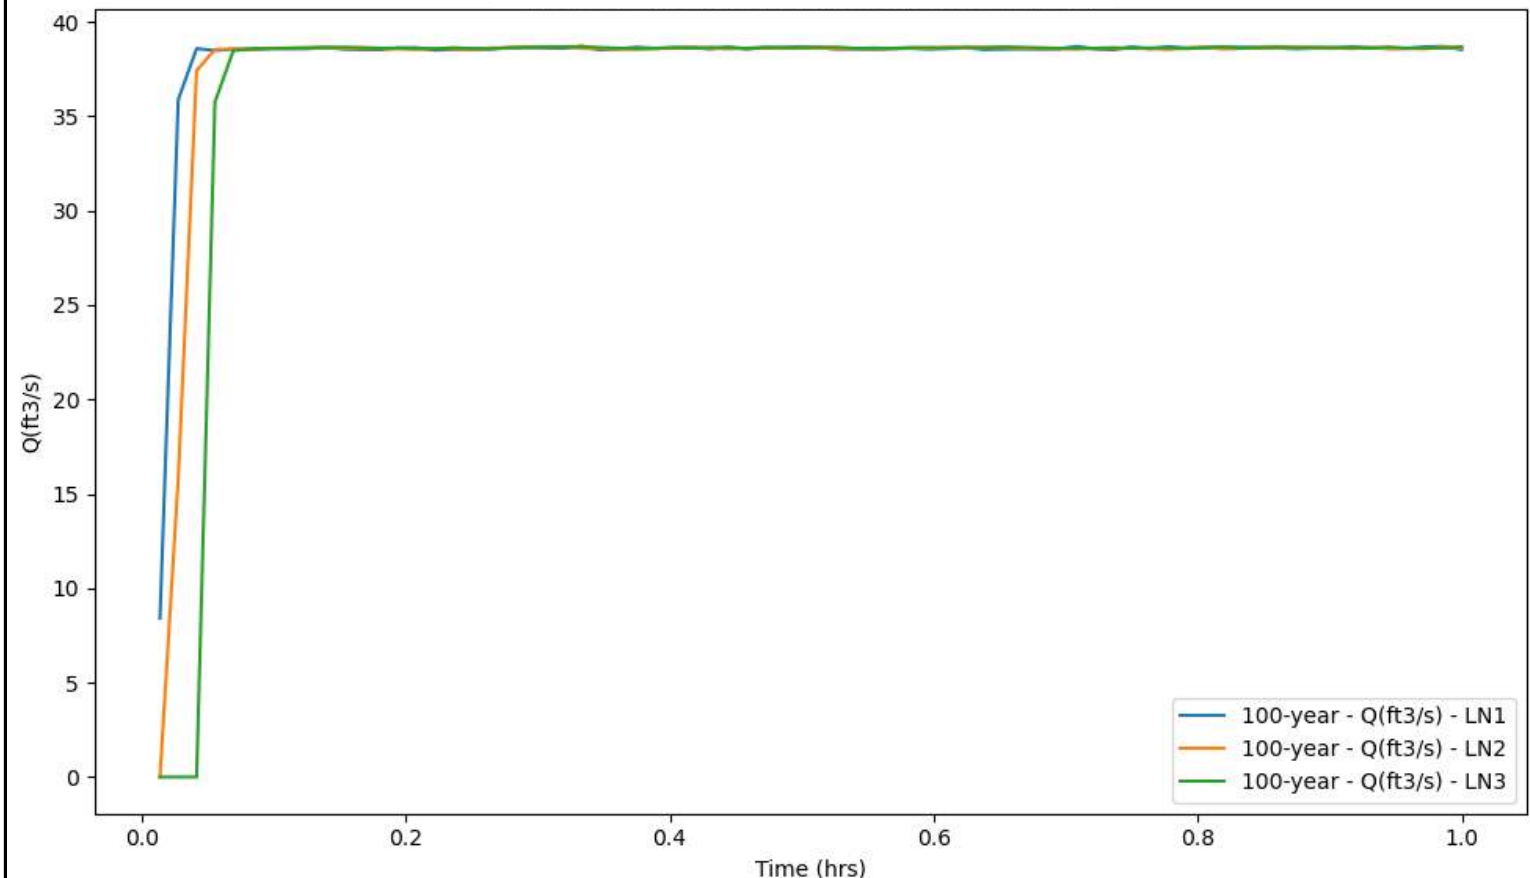
PROPOSED 100-YEAR RESULTS

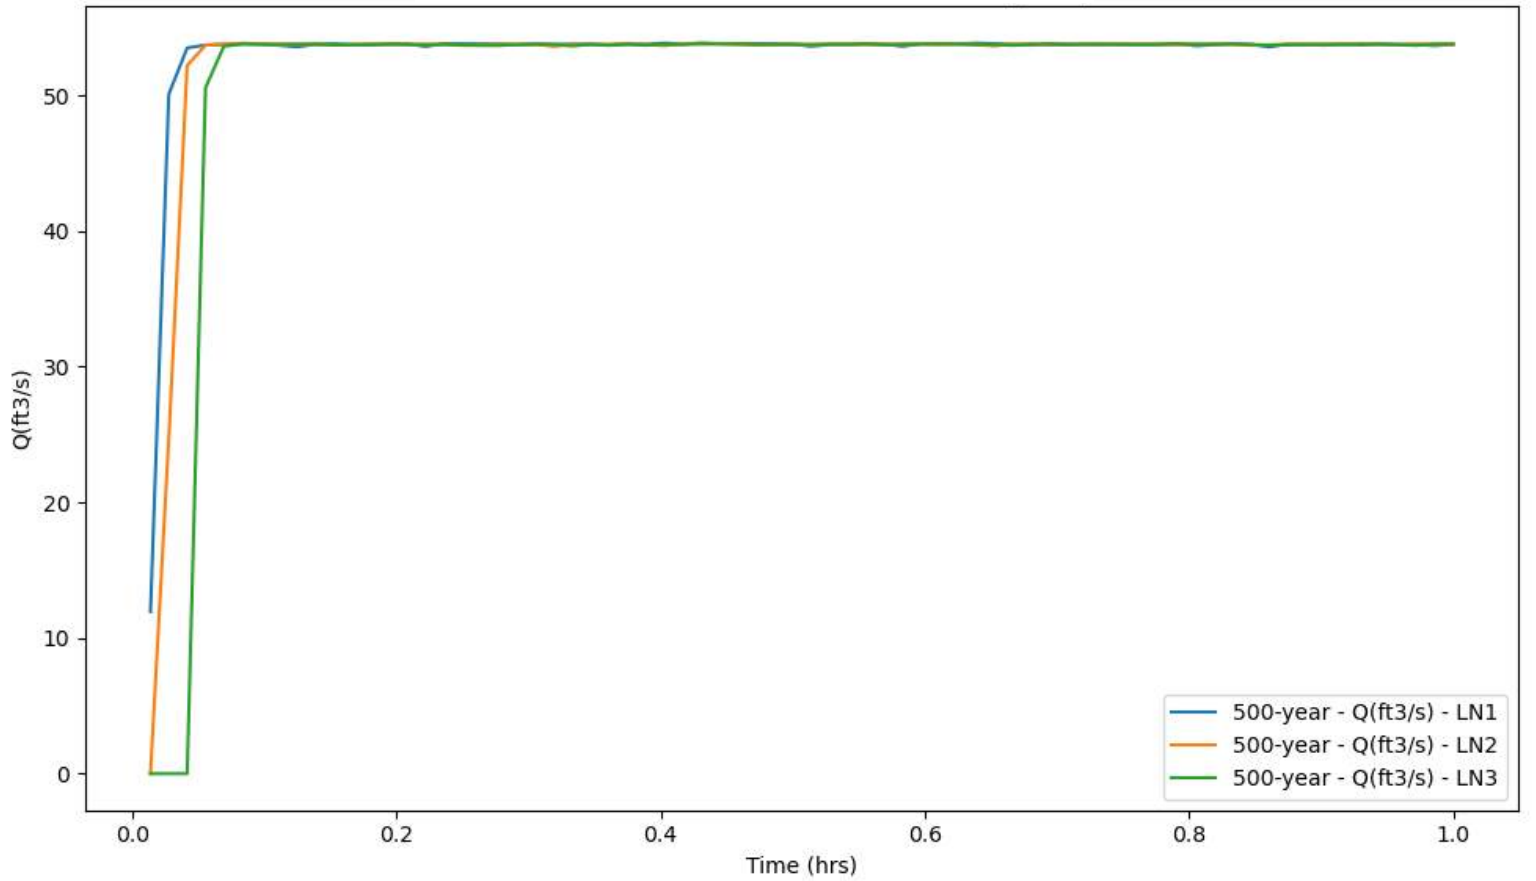
PROPOSED 500-YEAR RESULTS

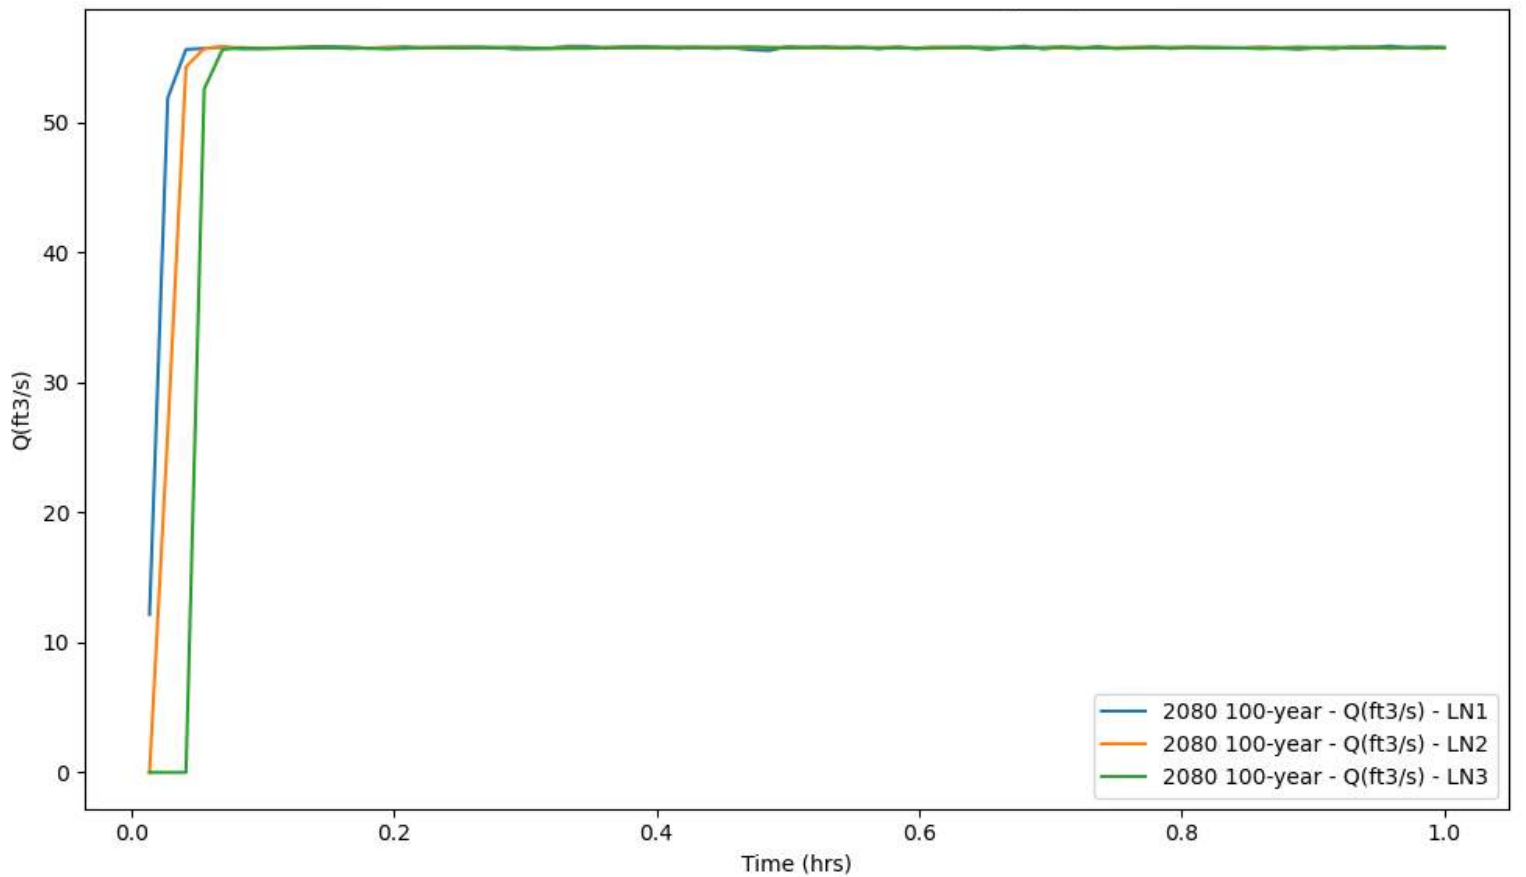
PROPOSED 2080 100-YEAR RESULTS

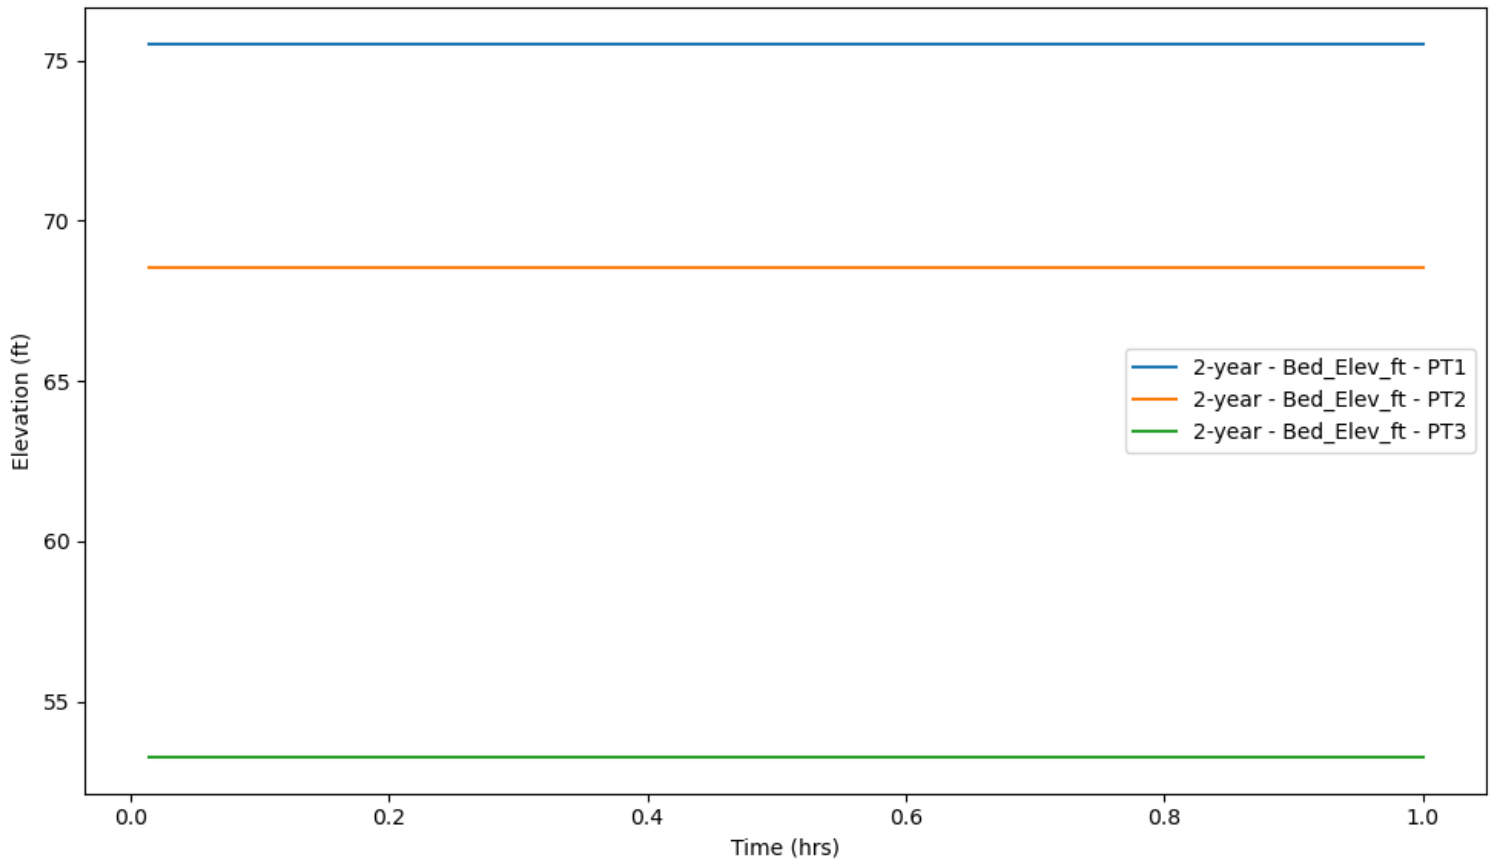
PROPOSED 2-YEAR RESULTS

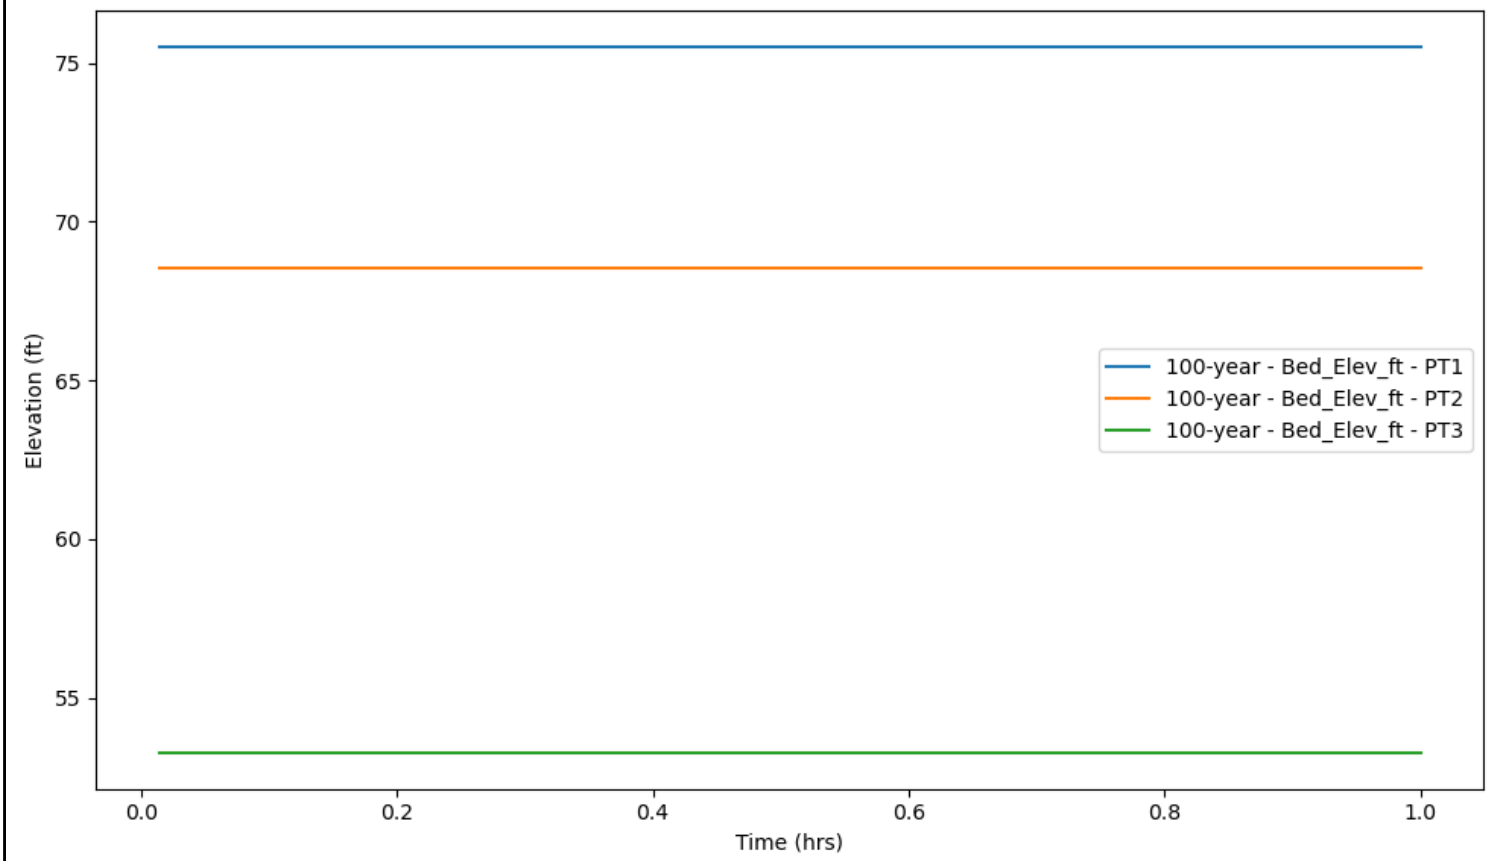
PROPOSED 100-YEAR RESULTS

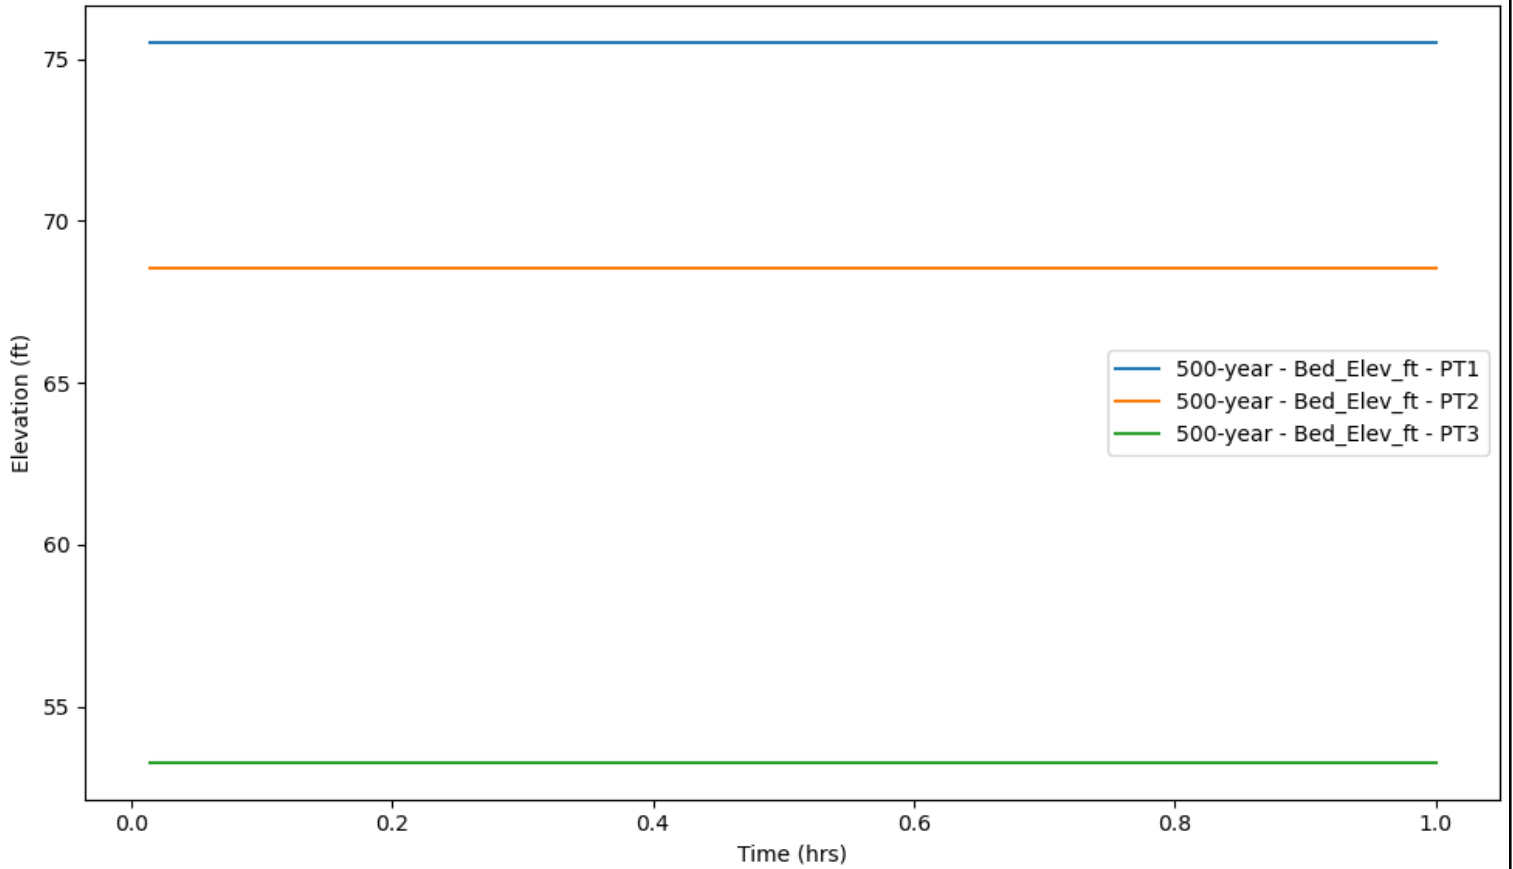
PROPOSED 500-YEAR RESULTS

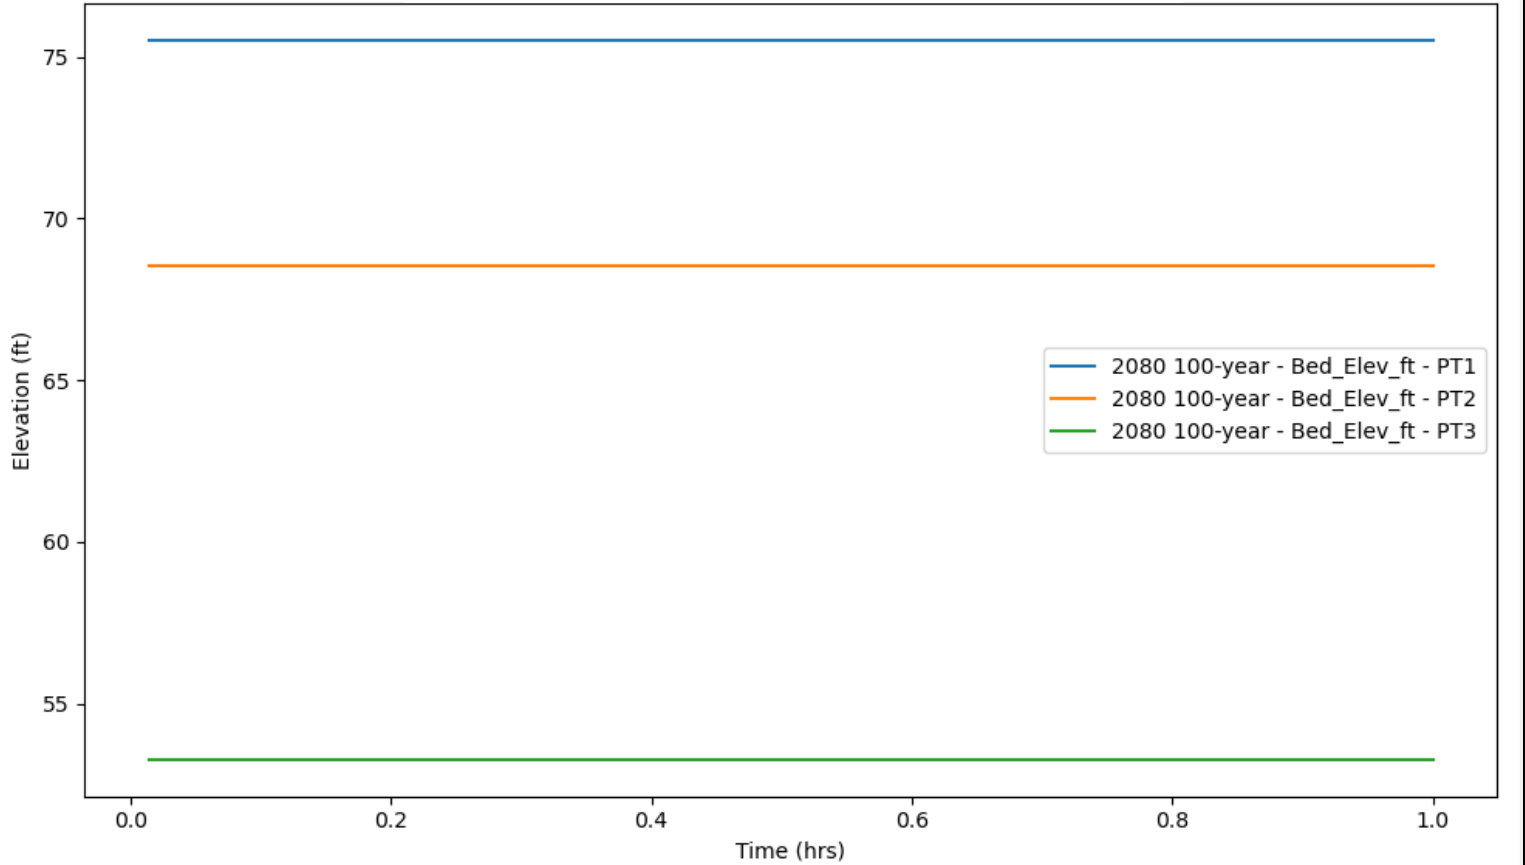
PROPOSED 2080 100-YEAR RESULTS
